STRUCTURAL INSPECTION

Telescope inspectors reach for the stars in West Virginia

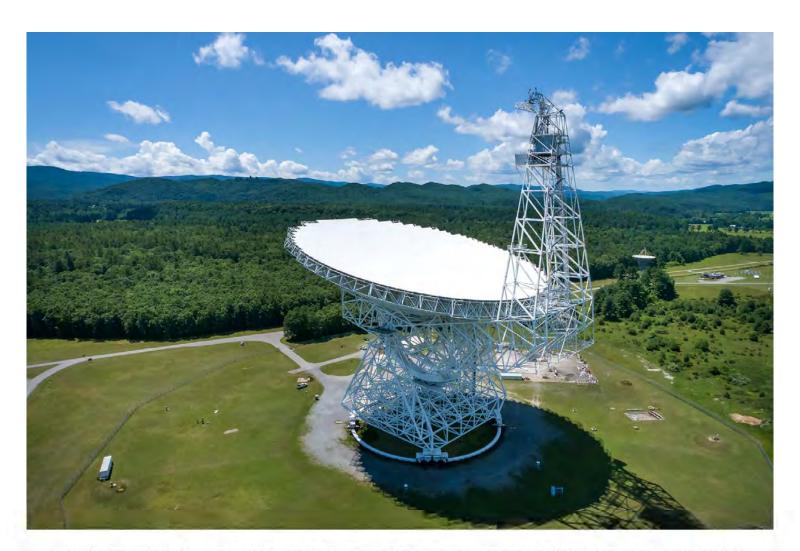
Weighing more than 17 million lb, the Robert C. Byrd Green Bank Telescope can rotate a full 360 degrees on its base and tilt the reflector dish forward and back over a 90-degree range. This enables the telescope to track objects across almost the entire sky. (Photograph courtesy of Modjeski and Masters)

Framed in more than 1,300 individual steel elements — some as thin as 5/64 in., others forming components 8 ft in diameter — the telescope is a massive structure that seems to defy gravity. Weighing more than 17 million lb, it can rotate a full 360 degrees on its base, with 16 motorized wheels turning the structure around a 210 ft diameter track. Other motors tilt the enormous reflector dish forward and back over a 90-degree range, bringing the edge of the dish to within 20 ft of the ground. Together, the rotation and tilting features enable the telescope to track objects across almost the entire sky, excepting just the first few degrees above the horizon.

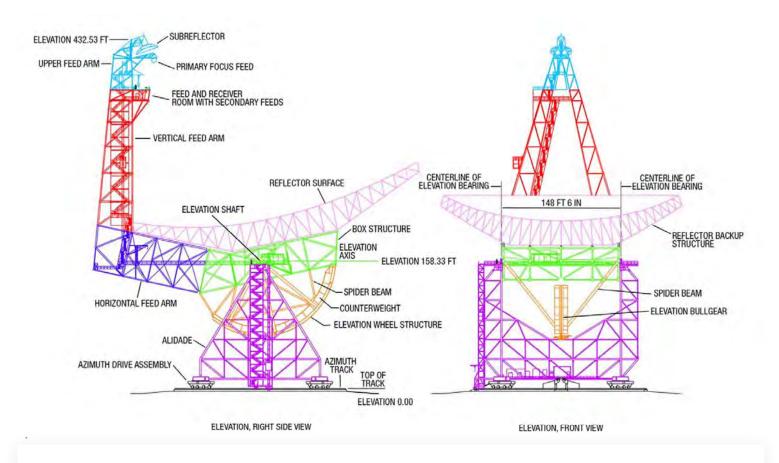
INSPECTION COMPONENTS (Image courtesy of Modjeski and Masters)

The telescope structure features a series of steel trusses that support the key components that the Modjeski and Masters team inspects at regularly scheduled periods, generally once every three years. Among the most significant of these components are:

- The alidade, or base, of the telescope, which features the motors and wheels that rotate the structure.
- The box structure, which includes the frame for the tilting structure and the 8 ft diameter elevation shaft that provides the primary support for the telescope's

tipping capability.

- The feed arms, which cantilever vertically off the box structure to support the signal receiver — the highest point on the structure, some 480 ft off the ground.
- The reflector backup structure, which features a frame of thin tubular members supporting the telescope's dish; the backup structure is inspected during alternate visits, one-half at a time.
- The elevation wheel structure, which includes the spider beams that support the box structure and transfer loads into the elevation shaft. This is also where the massive concrete-filled counterweight needed to balance the tilting structure is located.
